# the play inspection company

## Post Installation Report

Old Rec

The Street, Chilcompton, Radstock, Somerset, BA3  
4HB

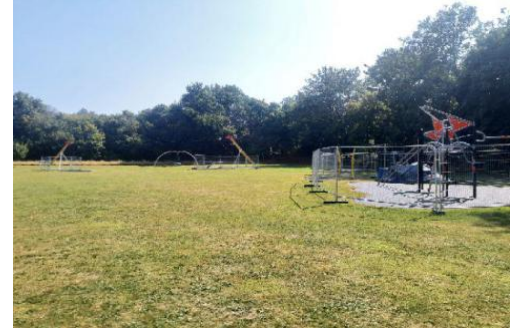
**Item:** Site General  
**Manufacturer:** Owner/Operator  
**Surface Type:** N/A  
**Item Quantity:** 1  
**Equipment Compliance:** N/A  
**Surface Area Compliance:** N/A

It is recommended that signage, with information including the site address, contact information for maintenance issues and emergency contact details are provided for the facility - Provide in accordance with the recommendations

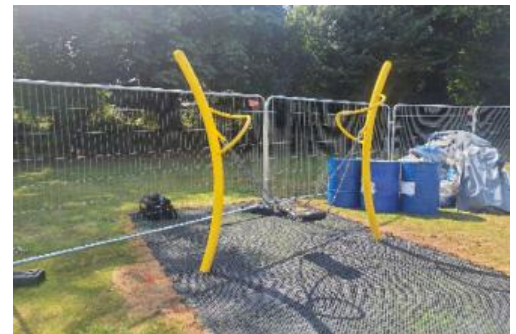
**Item:** Freeride  
**Manufacturer:** Hags  
**Surface Type:** Grass Matrix Tiles  
**Item Quantity:** 1  
**Equipment Compliance:** Yes  
**Surface Area Compliance:** Yes

This item is satisfactory - no work required -

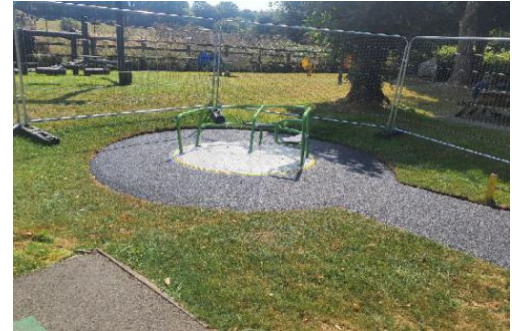
| <b>Item:</b> | Inclusive Roundabout |

The gate opens precisely to the edge of the free space of the roundabout and therefore users entering and exiting the play area will be encouraged to pass through the free space of the roundabout (NOTE - This is the only gate. Distance from roundabout to closed gate is 2930mm) - Refer to designer

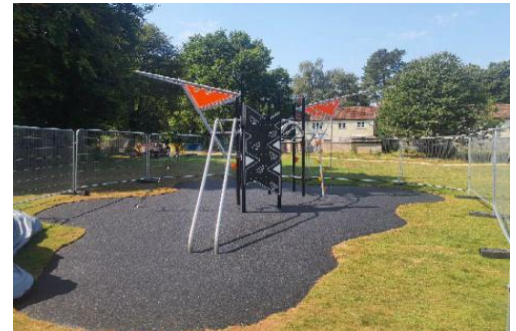
| <b>Item:</b> | Multi Play (Senior) |

There is/are finger entrapment/s in the structure and the item fails to meet the requirements of BS EN 1176 Part 1 4.2.7.6 Entrapment of fingers - Refer to manufacturer / contractor

There is/are finger entrapment/s in the str and the item fails to meet the requirements of BS EN 1176 Part 1 4.2.7.6 Entrapment of fingers - Refer to manufacturer / contractor

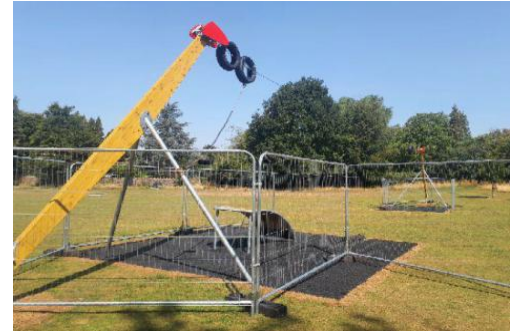
**Item:** Cable Runway  
**Manufacturer:** Hags  
**Surface Type:** Mixed Surface  
**Item Quantity:** 1  
**Equipment Compliance:** Yes  
**Surface Area Compliance:** Yes

NOTE - The fixings or components for this item are in excess of 2.50m above a standing surface and could not be fully accessed by the inspector. We have completed a visual inspection from a standing surface only. - Refer to contractor and ensure fixings / components are installed in line with manufacturer recommendations

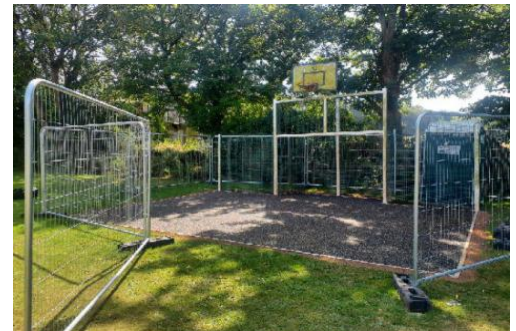
**Item:** Goalmouth and Basketball Post  
**Manufacturer:** Mant Leisure  
**Surface Type:** Flexi Pave  
**Surface Nominal Depth:** 55mm  
**Item Quantity:** 1  
**Equipment Compliance:** N/A  
**Surface Area Compliance:** N/A  
**Total Findings:** 1

NOTE - This is an existing item of equipment that has had a new surface installed; the equipment itself was not included within this inspection and only the new surfacing and any related findings were assessed. The surface was found to be satisfactory - no work required. -

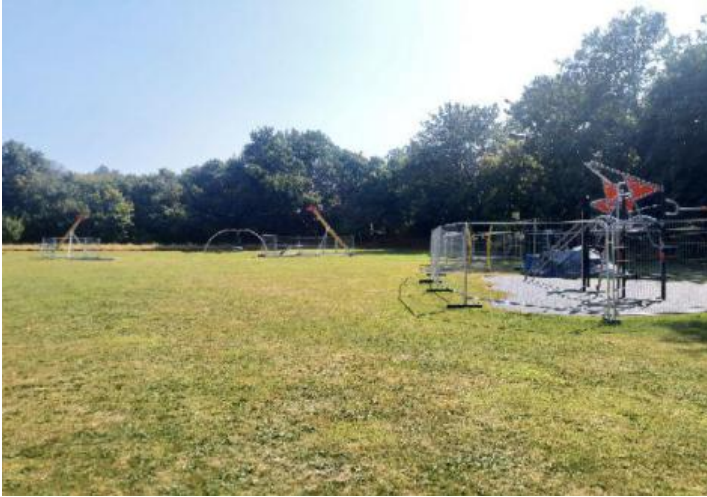
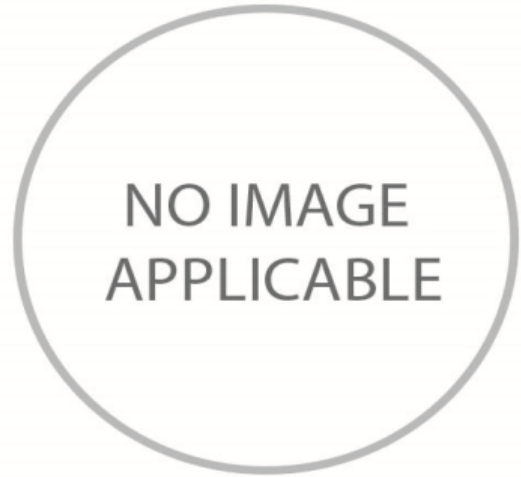
**Item:** Ancillary Items - Site General  
**Manufacturer:** Owner/Operator

**Finding:** It is recommended that signage, with information including the site address, contact information for maintenance issues and emergency contact details are provided for the facility

**Action:** Provide in accordance with the recommendations

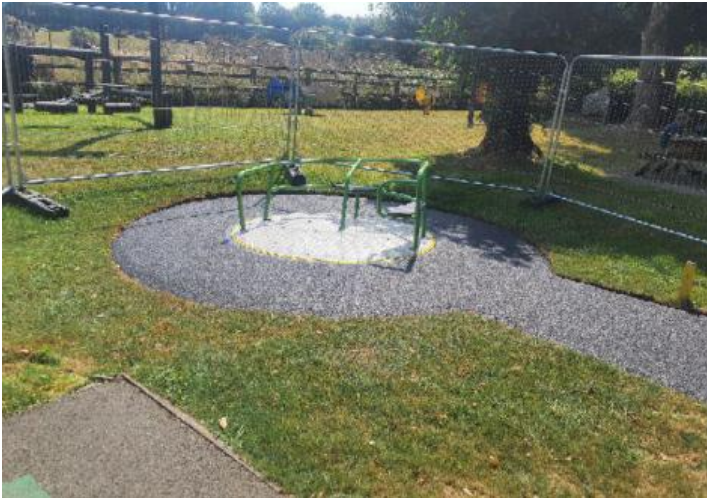
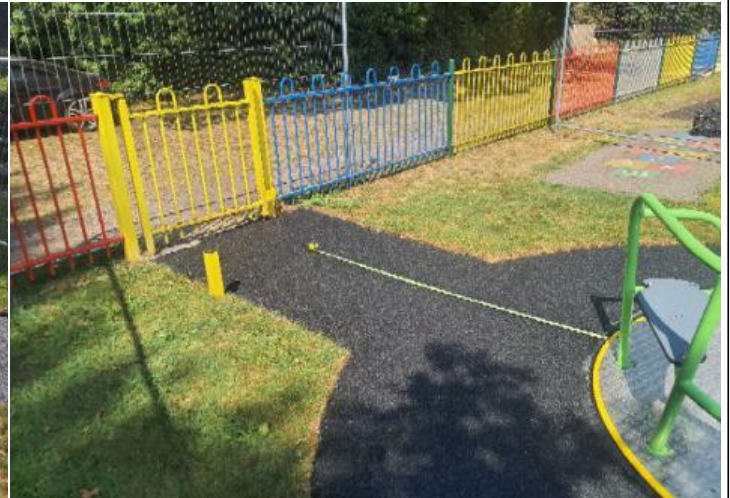
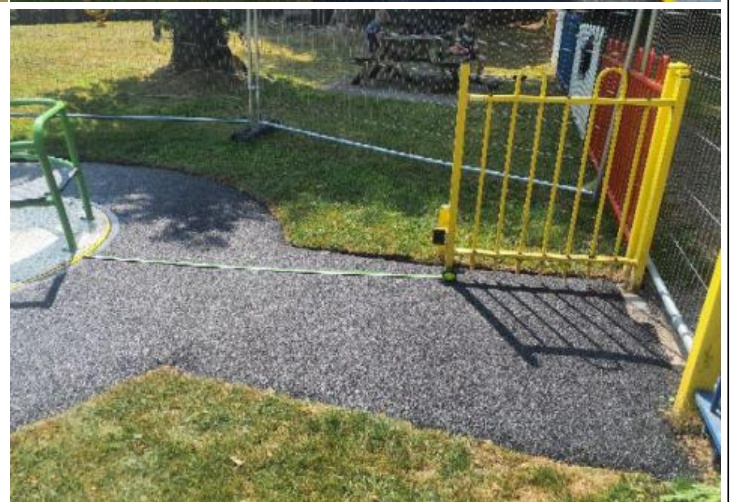
**Item:** Rotor Play - Inclusive Roundabout  
**Manufacturer:** Hags

**Finding:** The gate opens precisely to the edge of the free space of the roundabout and therefore users entering and exiting the play area will be encouraged to pass through the free space of the roundabout (NOTE - This is the only gate. Distance from roundabout to closed gate is 2930mm)

**Action:** Refer to designer

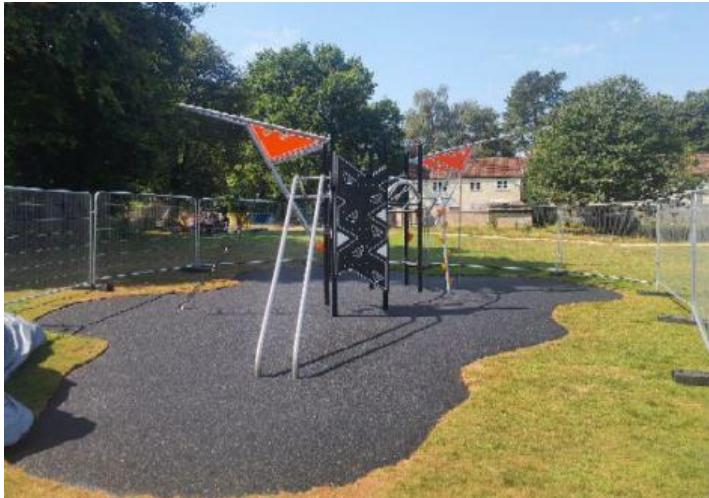
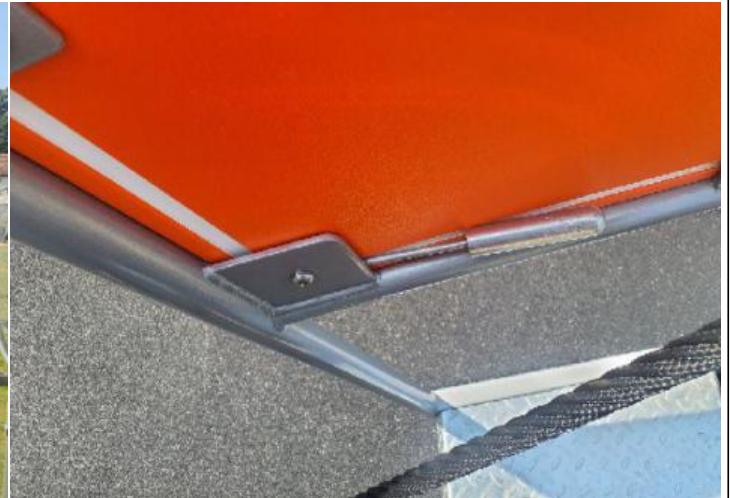
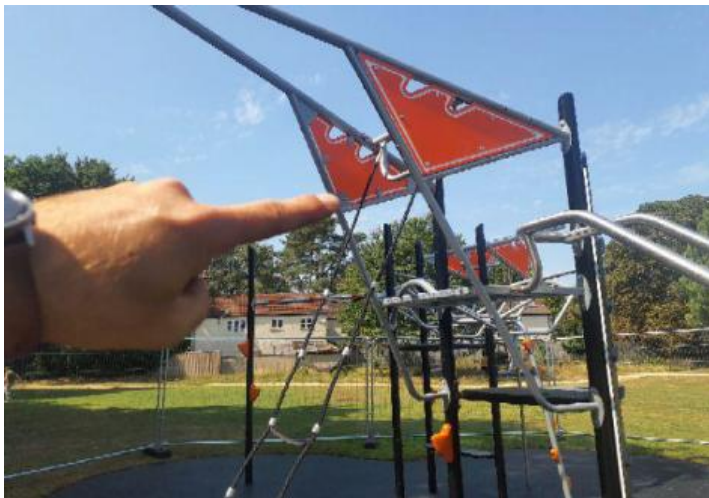
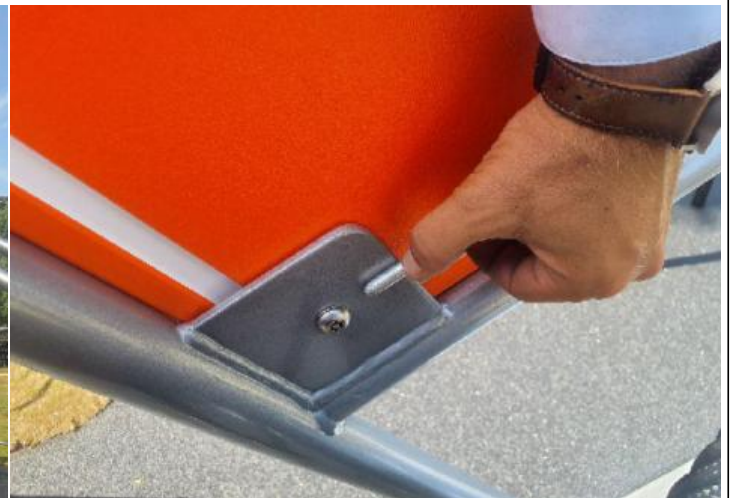
**Item:** Activity Equipment - Multi Play (Senior)  
**Manufacturer:** Hags

**Finding:** There is/are finger entrapment/s in the structure and the item fails to meet the requirements of BS EN 1176 Part 1 4.2.7.6 Entrapment of fingers

**Action:** Refer to manufacturer / contractor

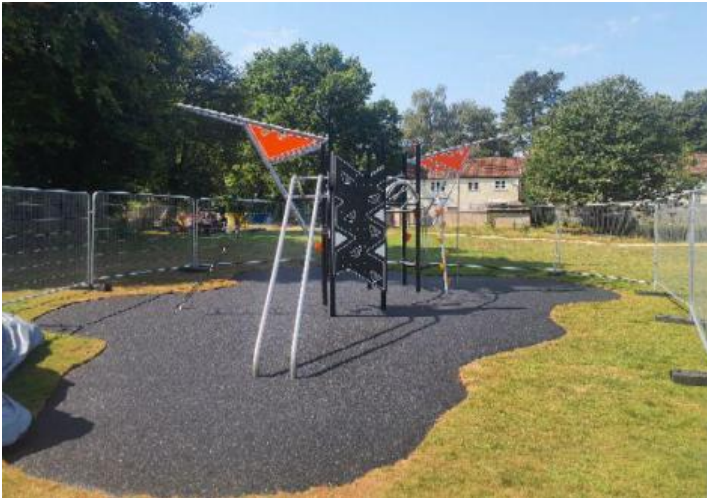
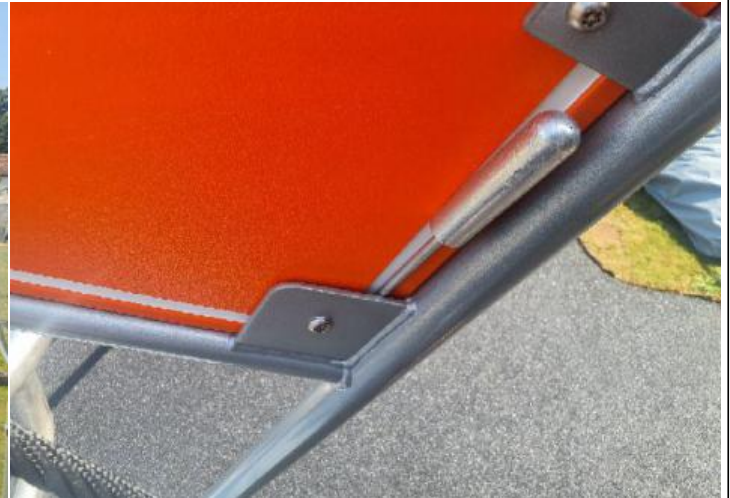
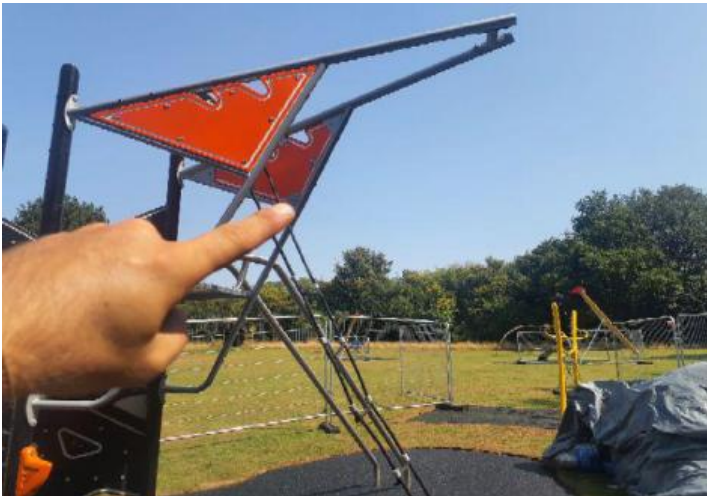
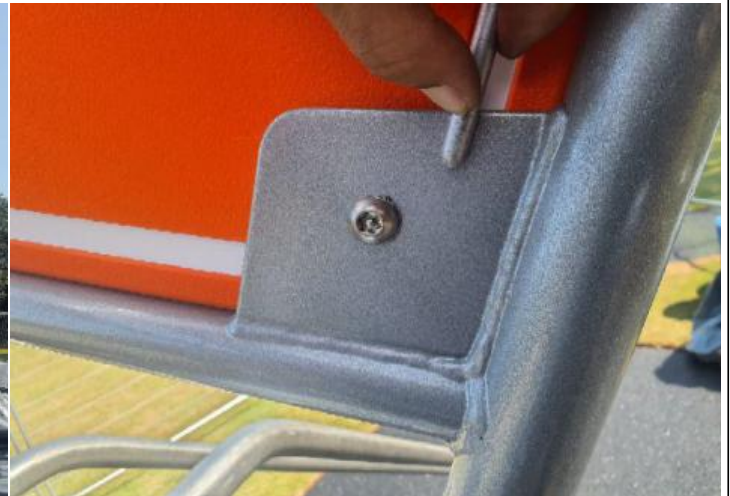
**Item:** Activity Equipment - Multi Play (Senior)  
**Manufacturer:** Hags

**Finding:** There is/are finger entrapment/s in the str and the item fails to meet the requirements of BS EN 1176 Part 1 4.2.7.6 Entrapment of fingers

**Action:** Refer to manufacturer / contractor

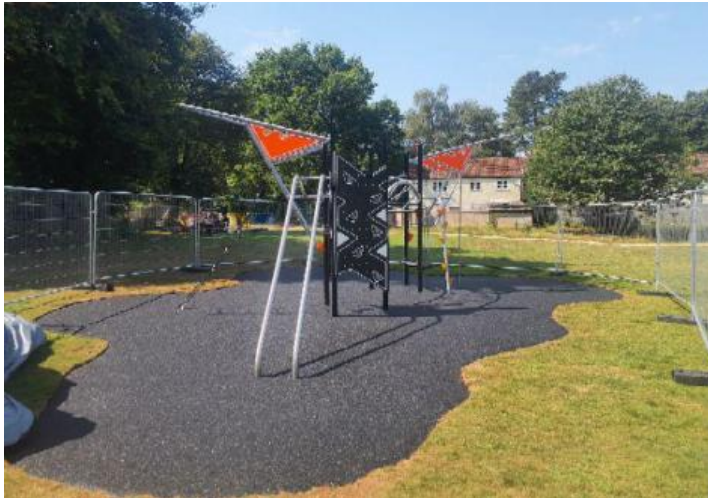
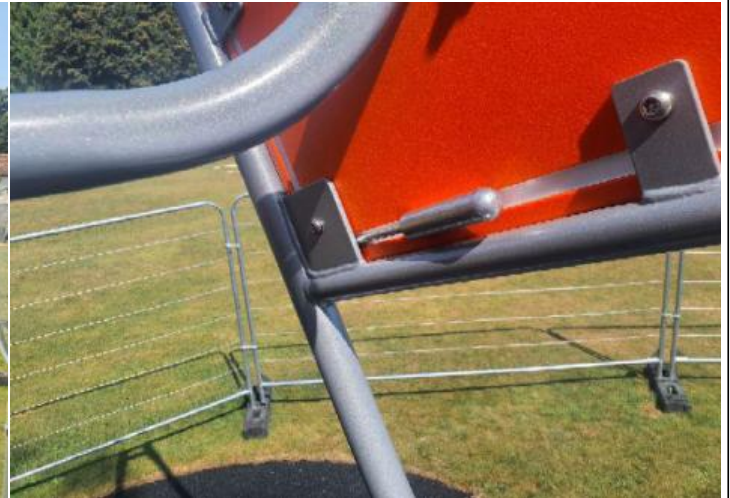
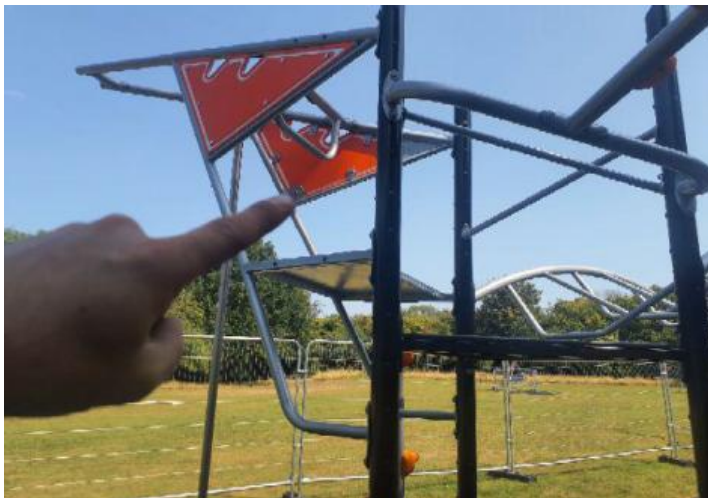
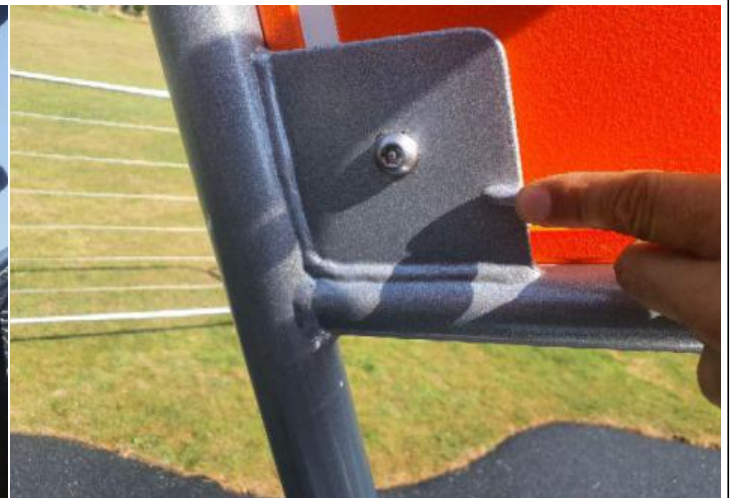
**Item:** Activity Equipment - Multi Play (Senior)  
**Manufacturer:** Hags

**Finding:** There is/are finger entrapment/s in the structure and the item fails to meet the requirements of BS EN 1176 Part 1 4.2.7.6 Entrapment of fingers

**Action:** Refer to manufacturer / contractor

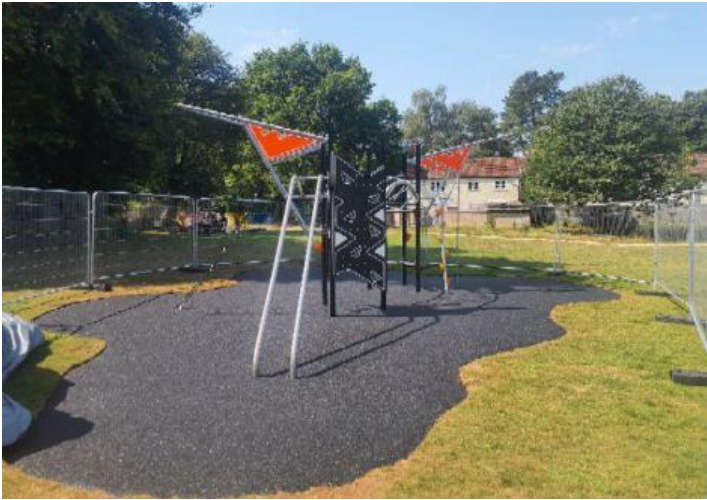
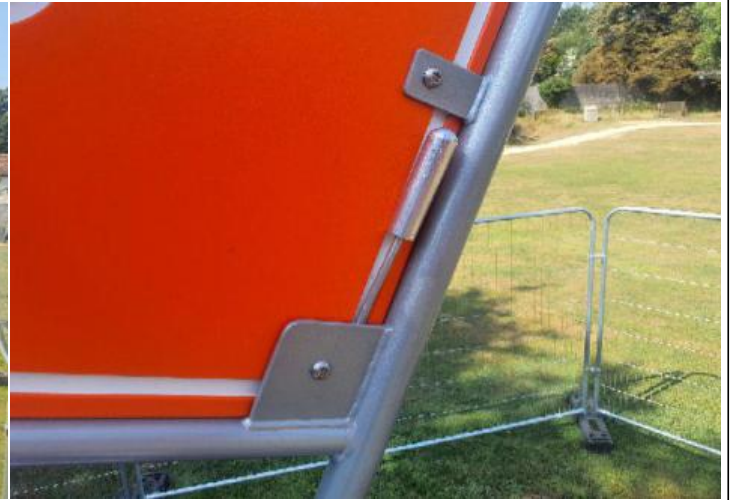
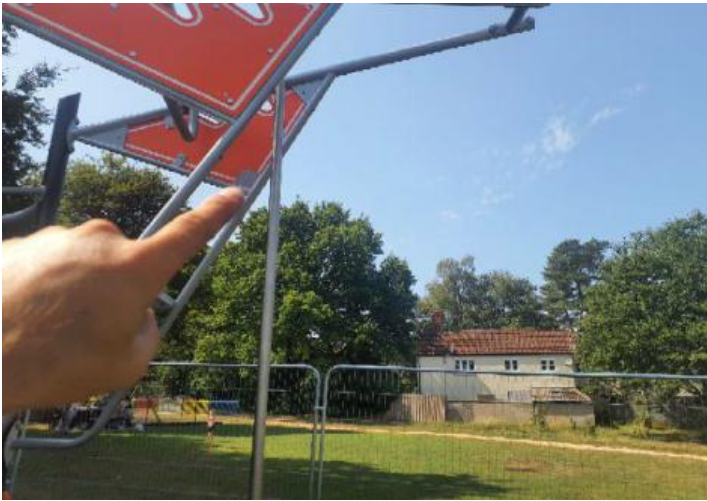
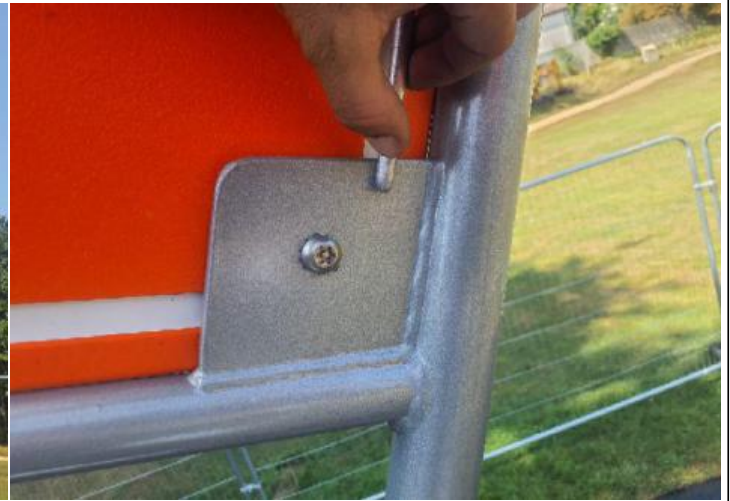
**Item:** Activity Equipment - Multi Play (Senior)  
**Manufacturer:** Hags

**Finding:** There is/are finger entrapment/s in the structure and the item fails to meet the requirements of BS EN 1176 Part 1 4.2.7.6 Entrapment of fingers

**Action:** Refer to manufacturer / contractor

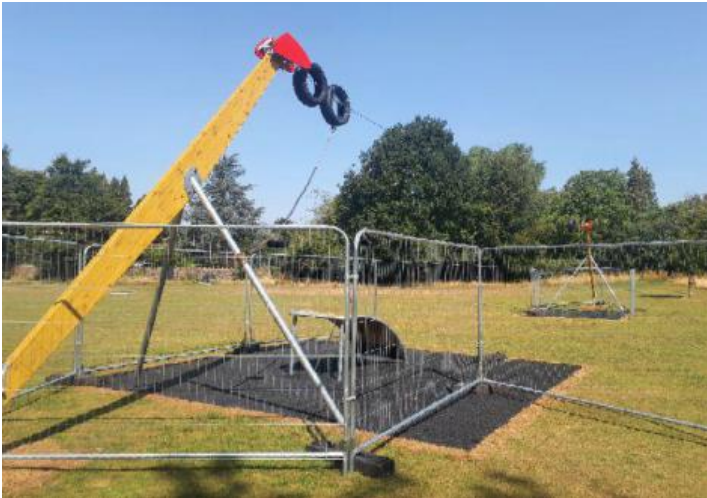
**Item:** Other - Cable Runway  
**Manufacturer:** Hags

**Finding:** NOTE - The fixings or components for this item are in excess of 2.50m above a standing surface and could not be fully accessed by the inspector. We have completed a visual inspection from a standing surface only.

**Action:** Refer to contractor and ensure fixings / components are installed in line with manufacturer recommendations

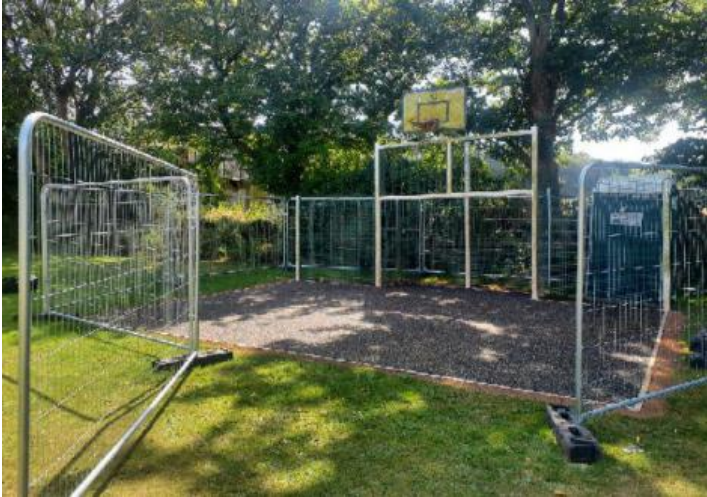
**Item:** Multi Use Games Area - Goalmouth and Basketball Post  
**Manufacturer:** Mant Leisure

**Finding:** NOTE - This is an existing item of equipment that has had a new surface installed; the equipment itself was not included within this inspection and only the new surfacing and any related findings were assessed. The surface was found to be satisfactory - no work required.
